Considerations over the Italian road bridge infrastructure safety after the Polcevera viaduct collapse:
past errors and future perspectives

Fabio Bazzucchi, Luciana Restuccia, Giuseppe Andrea Ferro

ABSTRACT. In the last four years, Italy experienced the collapse of five road bridge: Petrulla viaduct (2014), Annone (2016) and Ancona (2017) overpasses, Fossano viaduct (2017) and Polcevera (2018) bridge.

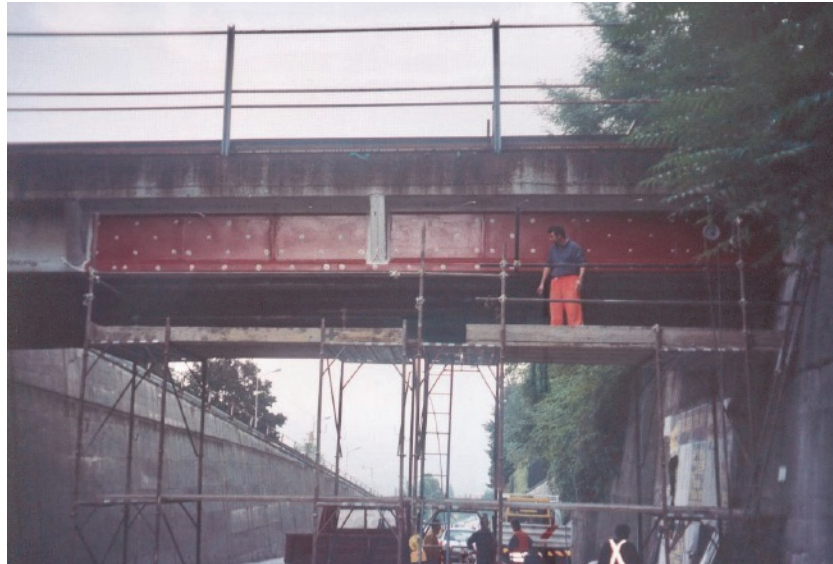
Figure 19: Steel resurfacing for I-beams of an overpass [Copyright: RELUIS].

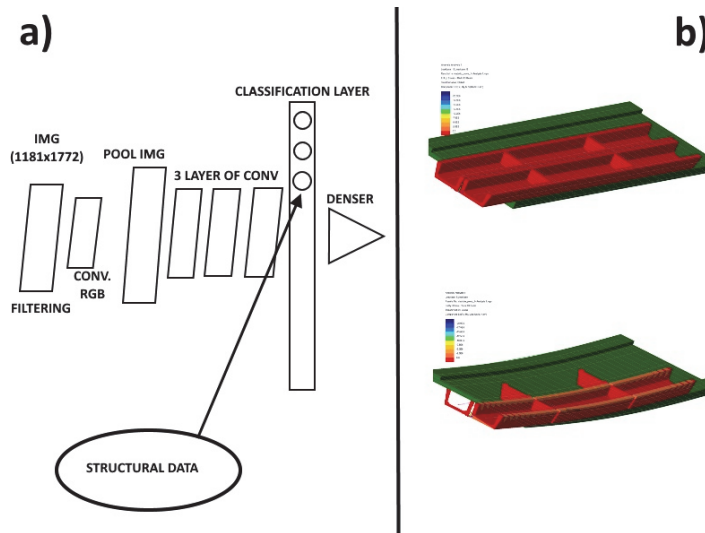
Figure 23: DCNN scheme (a); FEM tuned model (b).
